COMPOSITE PAVEMENT OVERLAY

PROJECT: US 130 MAIN STREET TO US ROUTE 1

2018 NJ Asphalt Paving Conference

PAVEMENT DESIGN

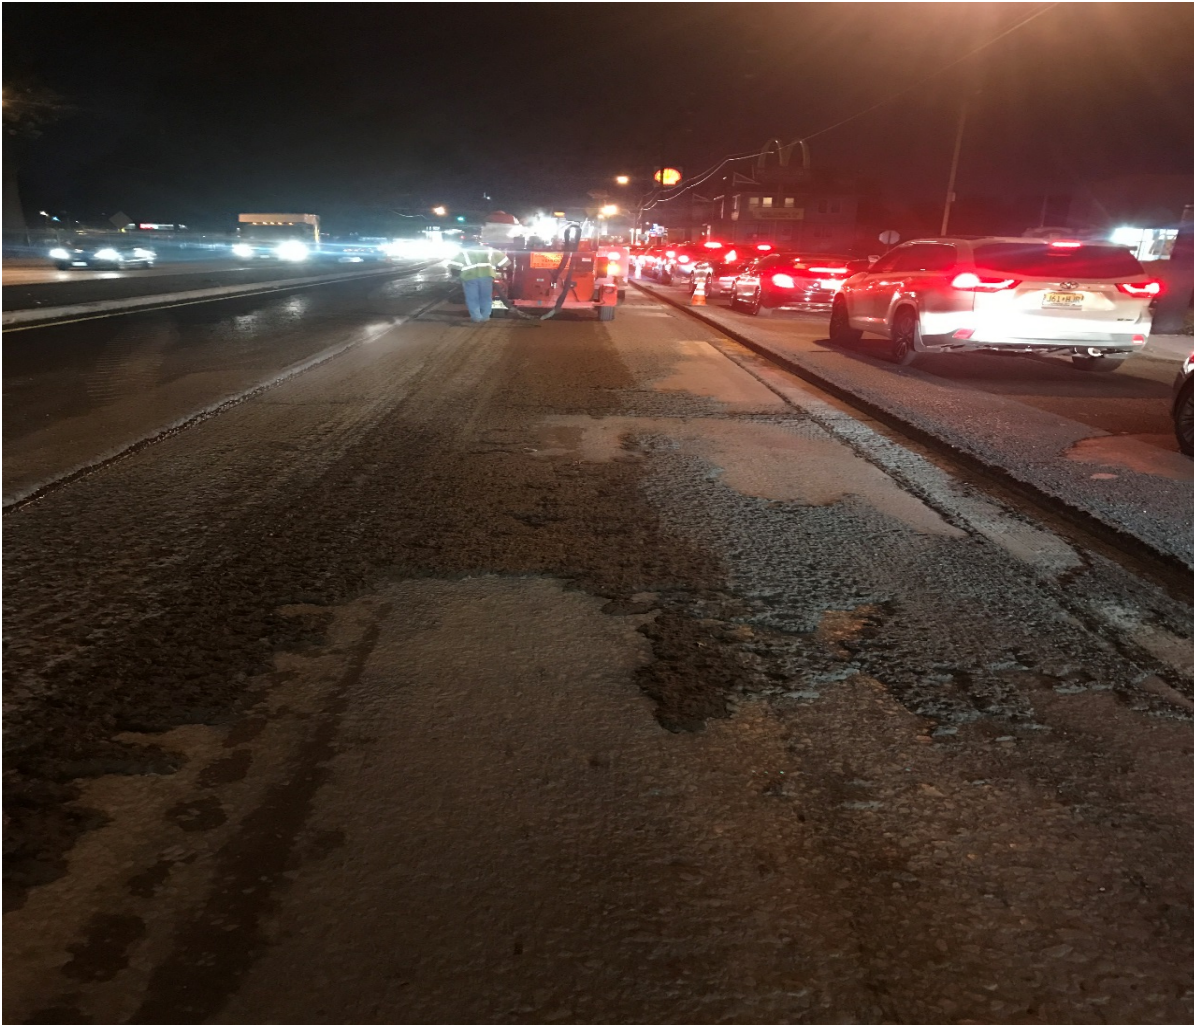
Challenges of Removing HMA Overlay:

Pavement Recommendation:

Mill 3" and Pave with 3" SMA
12.5 MM Surface Course

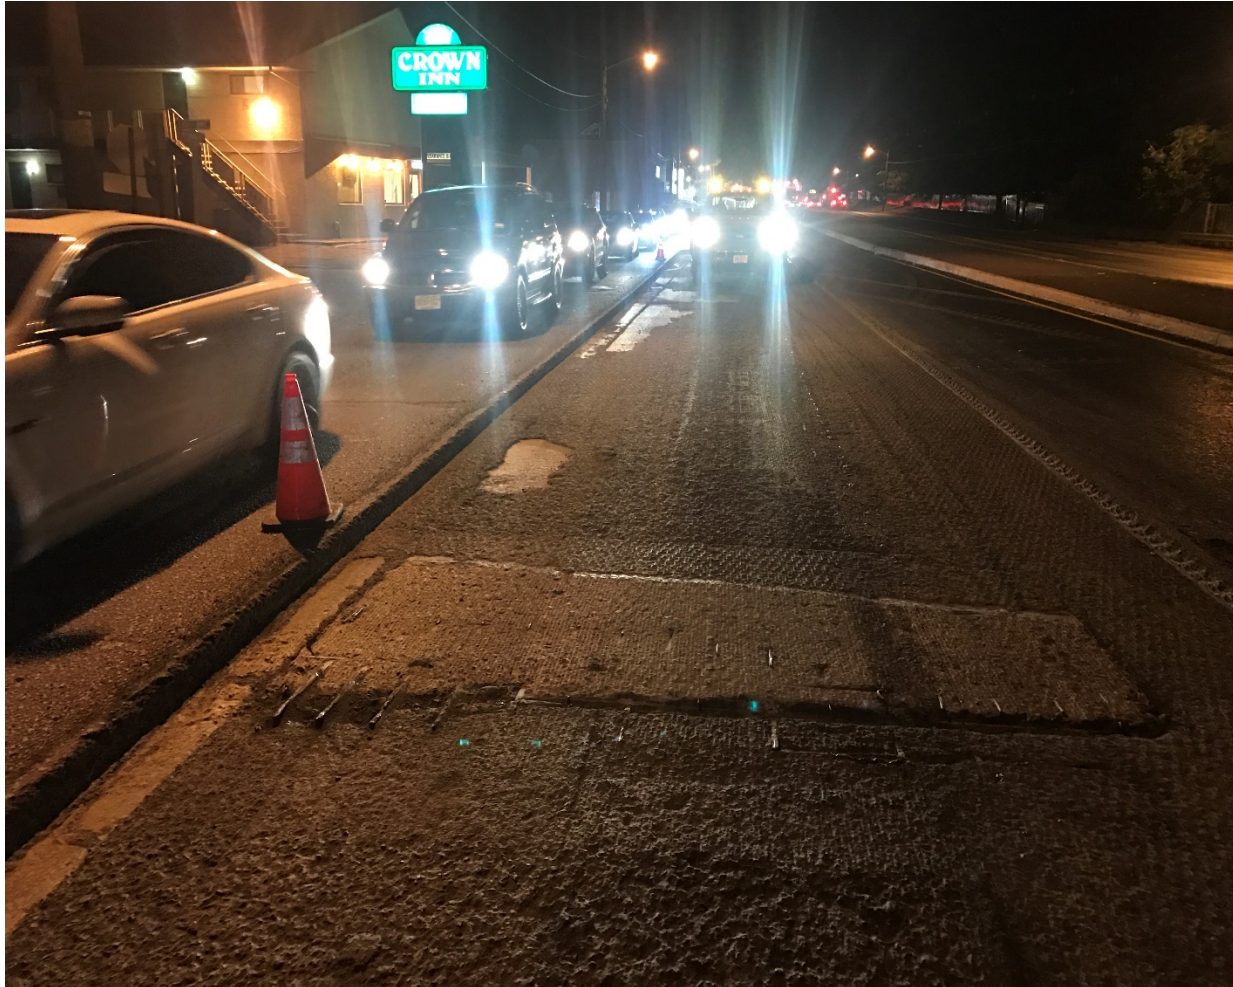
Challenges of Removing HMA Overlay:

Core Information:

Lane 1 Core information was 5.25" to 7.75" HMA over PCC.

Lane 2 Core information was not available during design.

Lane 3 Core information was 3.5" to 19.5" HMA over PCC.

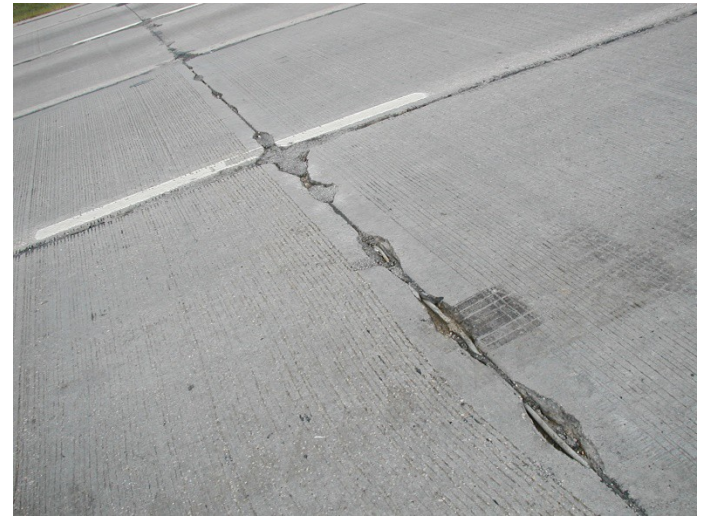
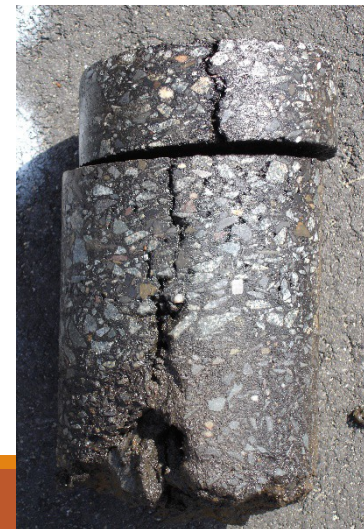
Modes of Reflective Cracking

- Mode 1 – Poor Load Transfer at joint/crack results in independent movement of PCC slabs
- Mode 2 – Excessive Vertical Bending at PCC joint/crack (Pure Tensile Straining)
- Mode 3 – Horizontal Deflections (PCC slab expansion and contraction) due to environmental cycling

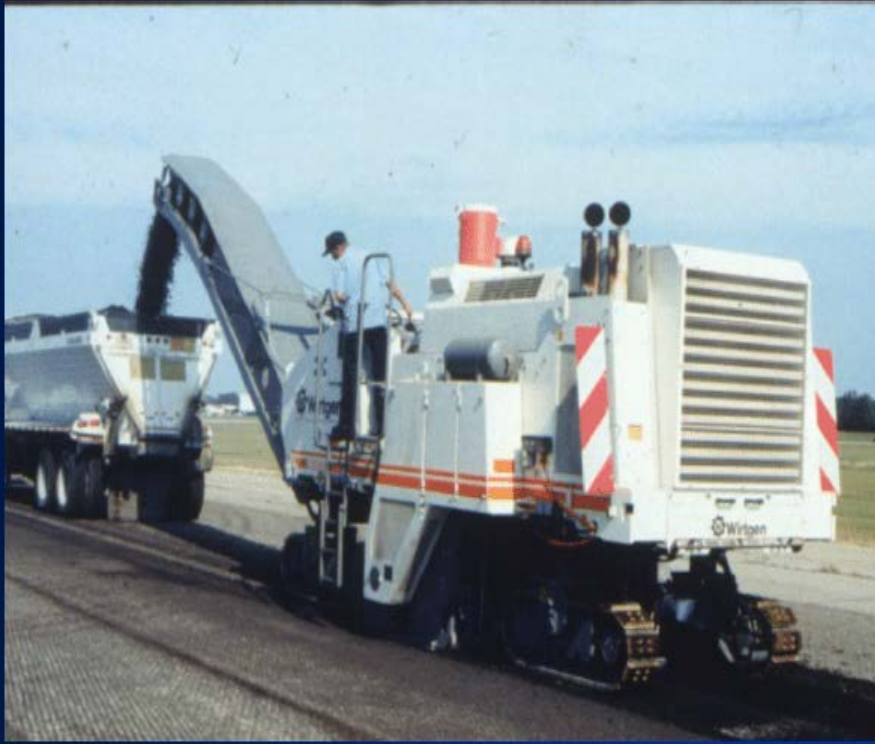
Mill & Overlay with HMA

Surface Milling

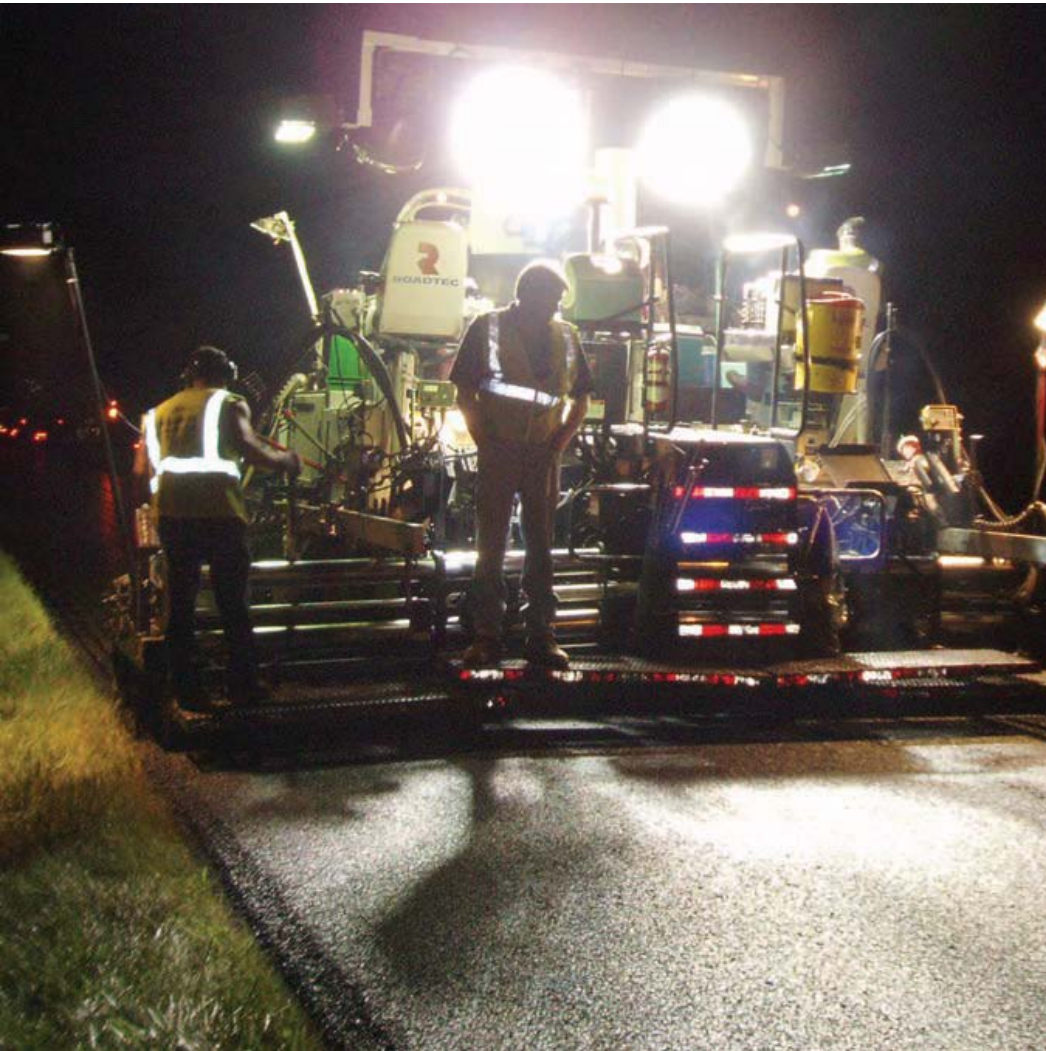
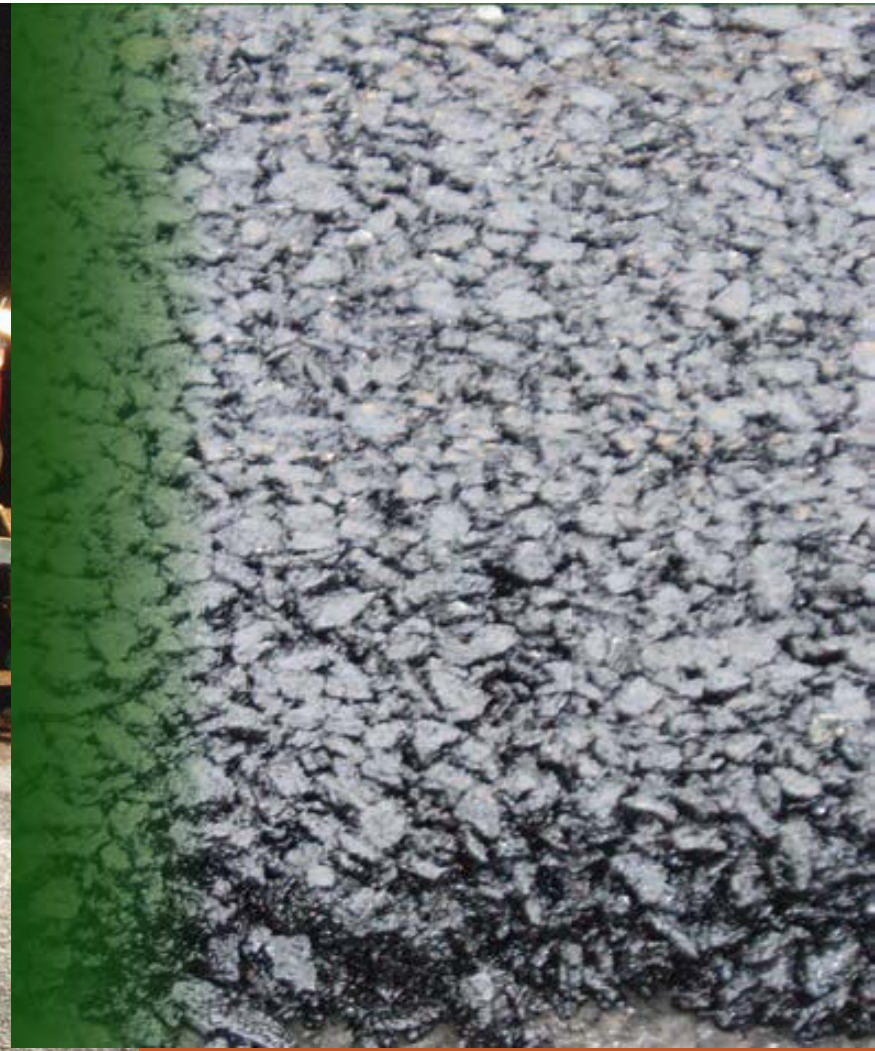
Asphalt Rubber Open Graded Friction Course

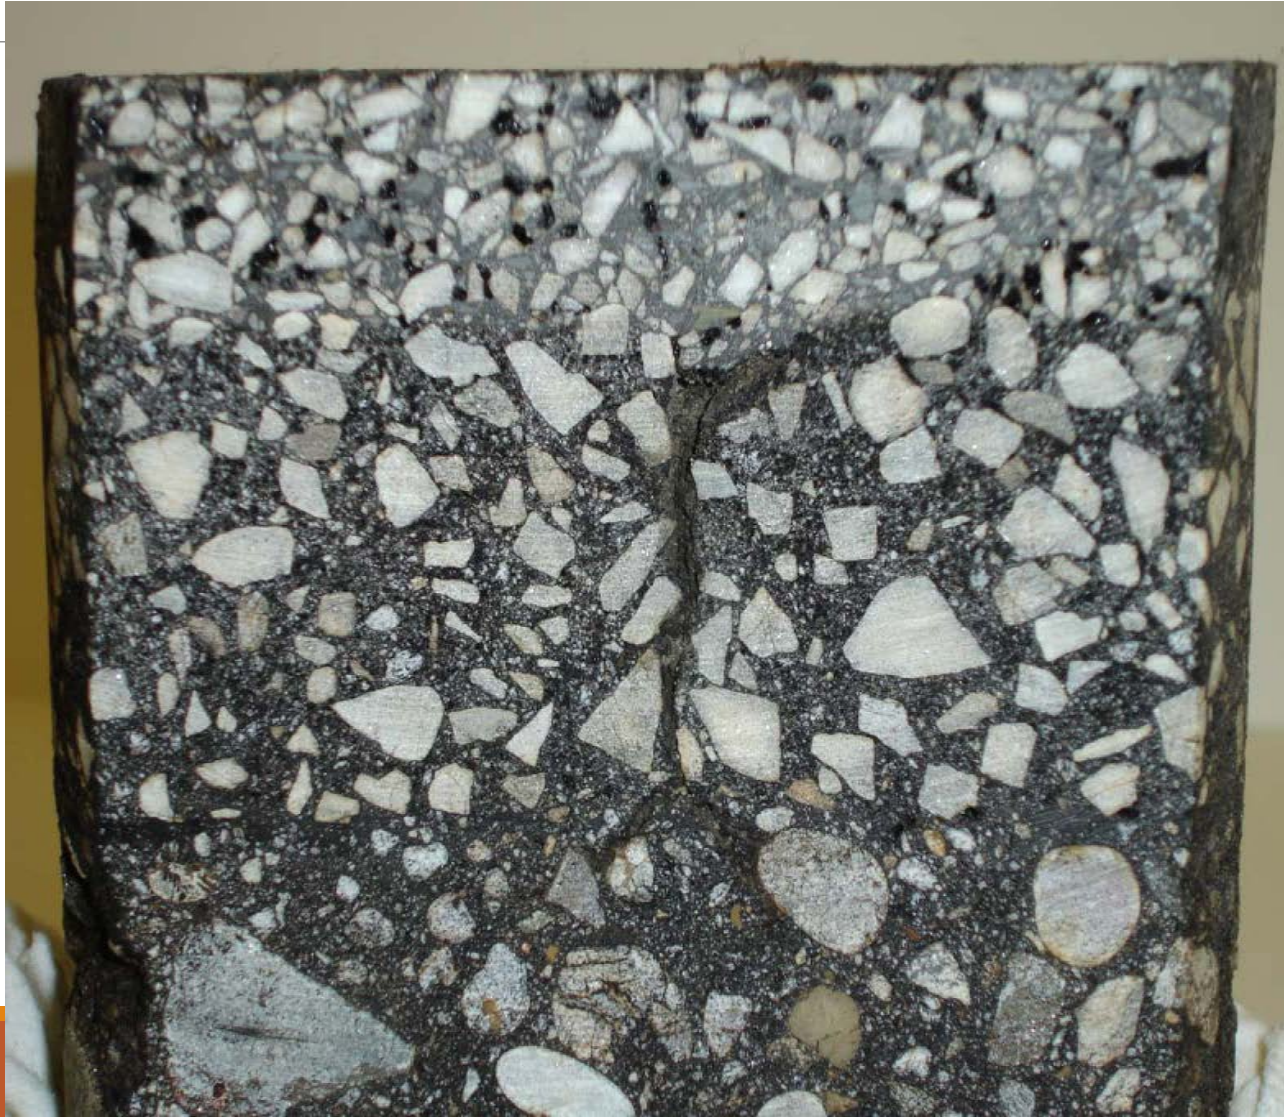
High Performance Thin Overlay

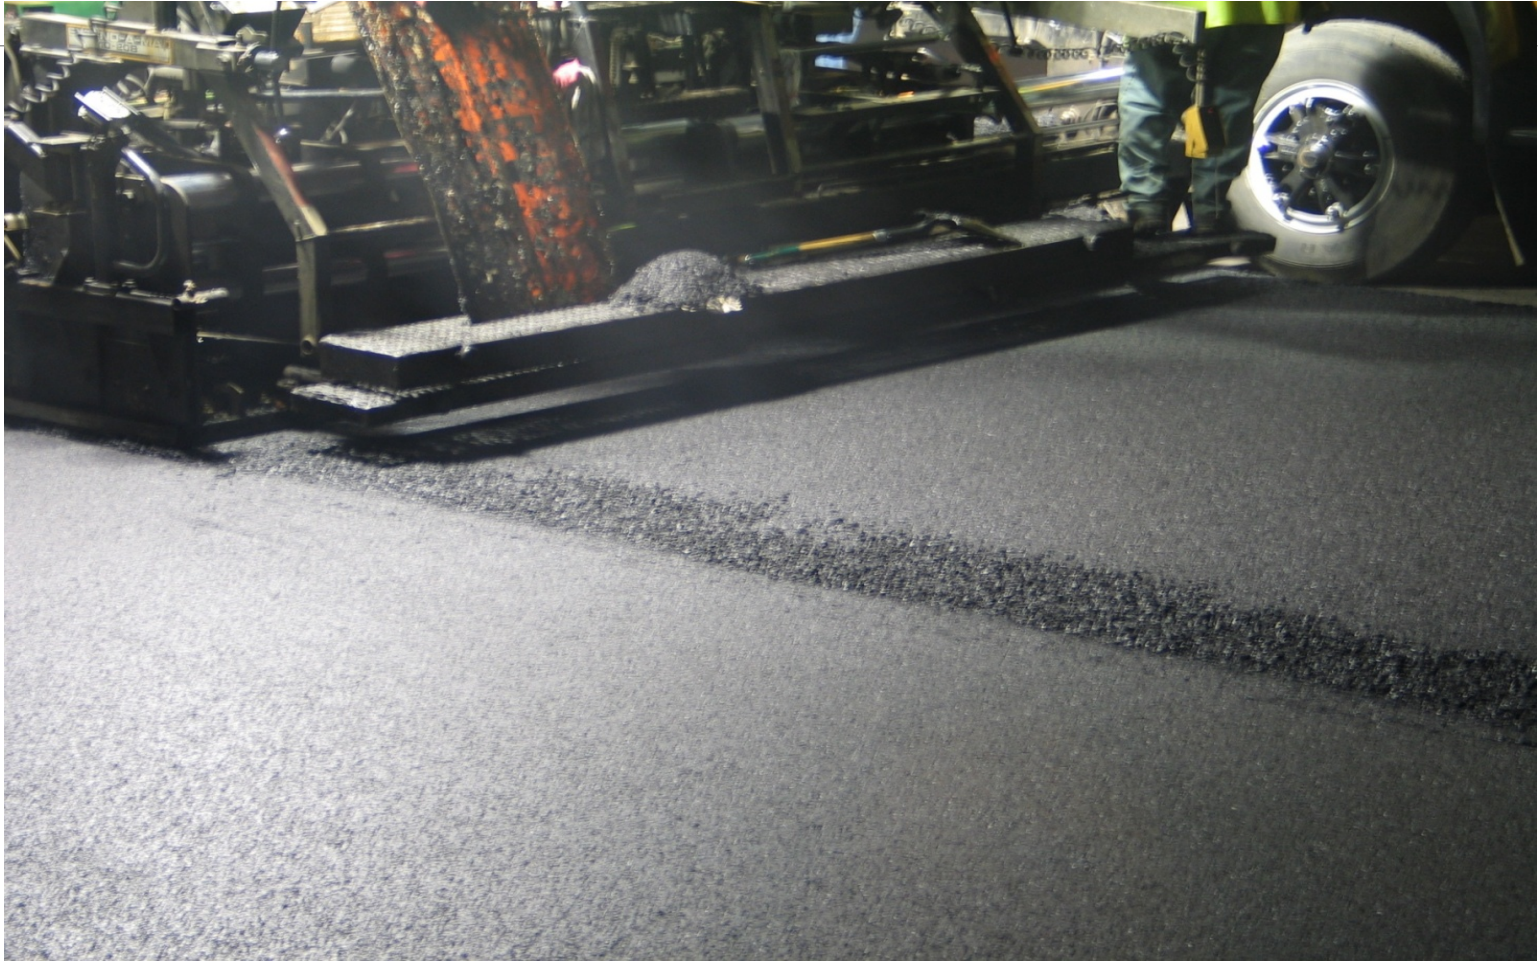
SMA 12.5mm Surface Course

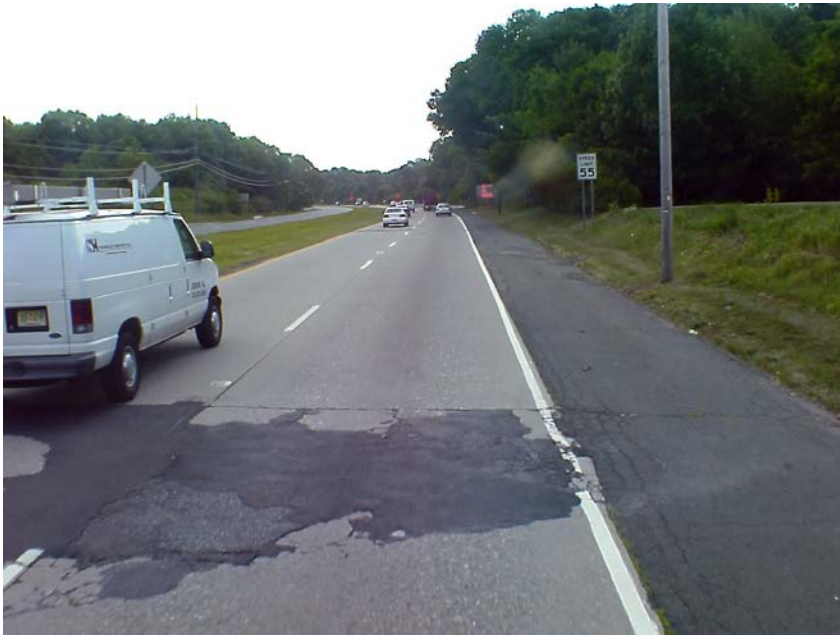
BEFORE REHAB

SDI = 2.07

- MP 13.4-14.75, IRI=197.2
- MP 14.75-15.25, IRI=154.7
- MP 15.25-15.75, IRI=143.8
- MP 15.75-17.03, IRI=151.5
- Ride Quality for the project, IRI=168.6

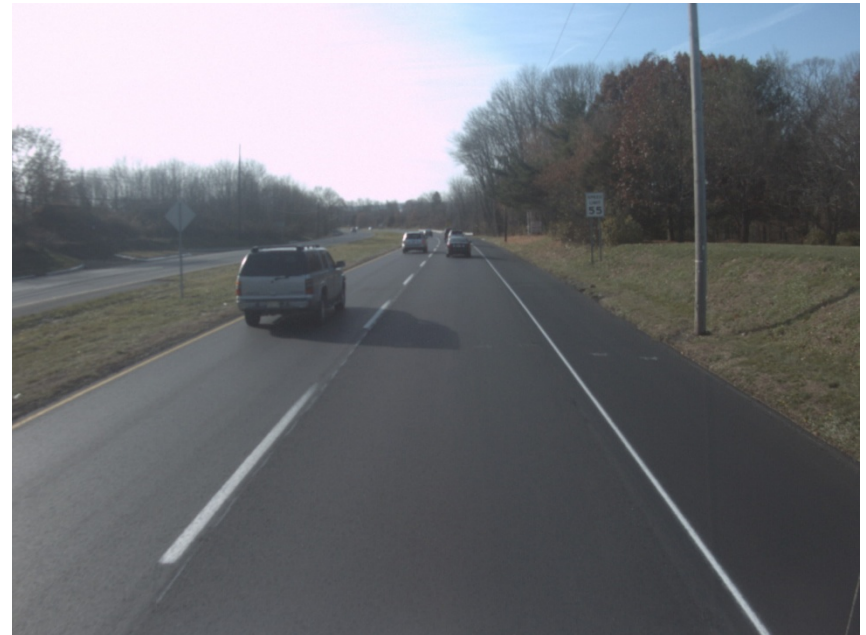
AFTER REHAB

SDI = 5.0

- MP 13.4-14.75, IRI=88.3
- MP 14.75-15.25, IRI=78.0
- MP 15.25-15.75, IRI=77.7
- MP 15.75-17.03, IRI=75.0

Ride Quality for the project,
IRI=80.4

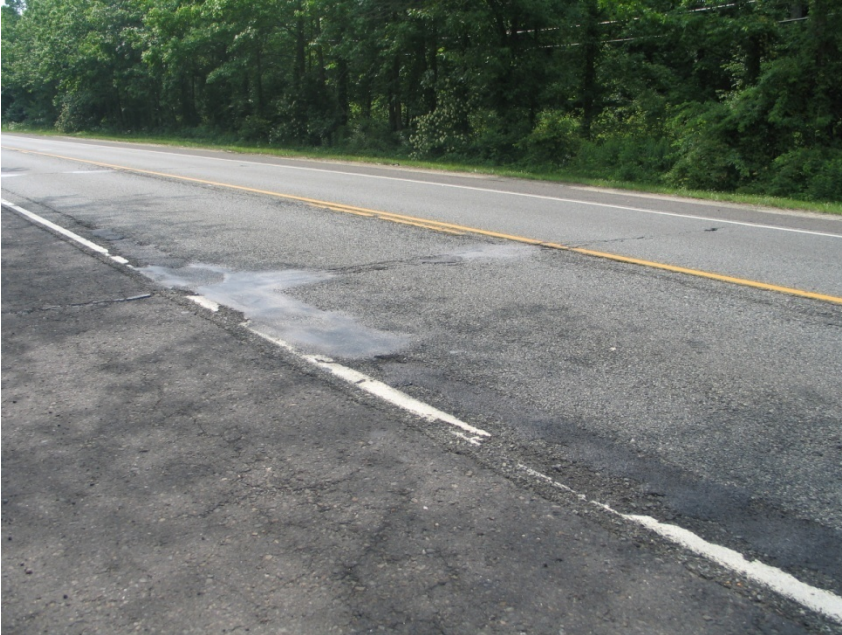
BEFORE REHAB

SDI = 1.56

Ride Quality IRI = 157

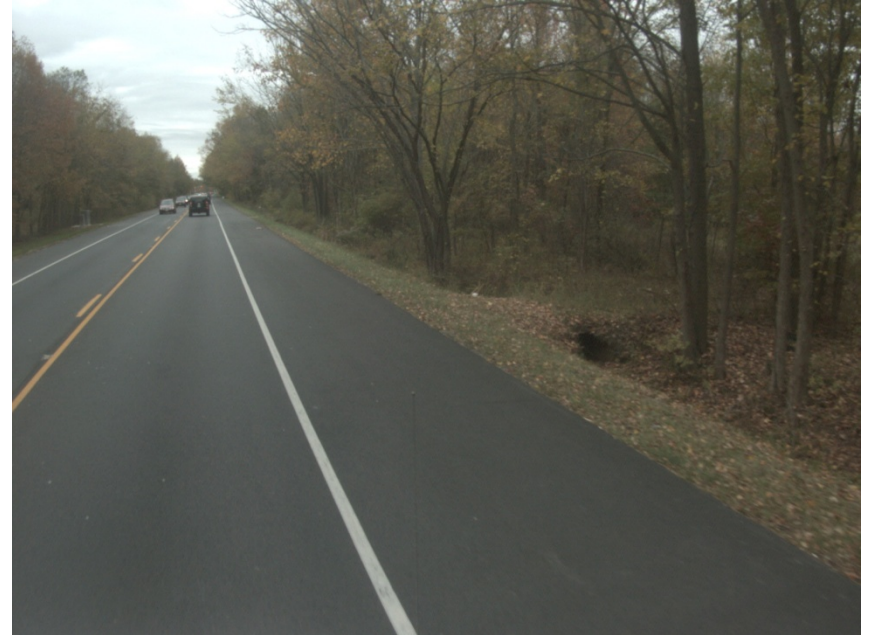
AFTER REHAB

SDI = 4.9

Ride Quality IRI = 94

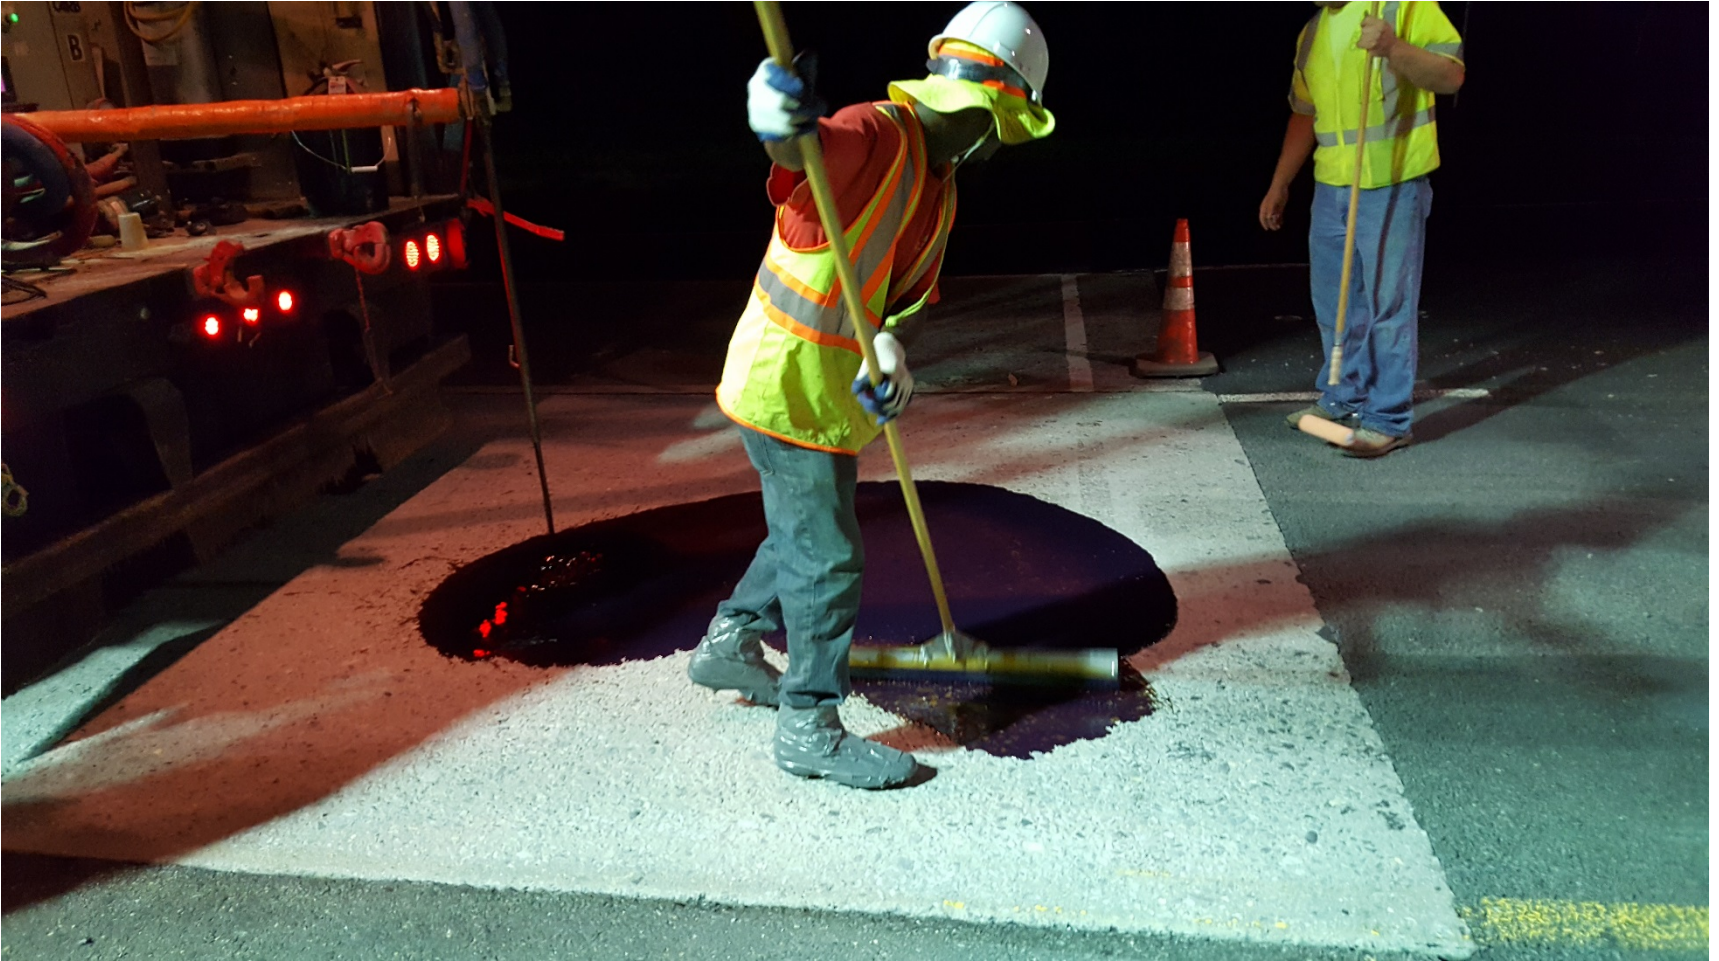
HFST

High friction surface treatments (HFST) are pavement treatments that dramatically and immediately reduce crashes, injuries, and fatalities associated with friction demand issues, such as:

- A reduction in pavement friction during wet conditions, and/or**
- A high friction demand due to vehicle speed and/or roadway geometrics.**
